TECHNICAL BULLETIN

JTB00242
16 NOV 2011

Front Bumper Beam Pedestrian Impact Sensor Rework

The New XK (X150)

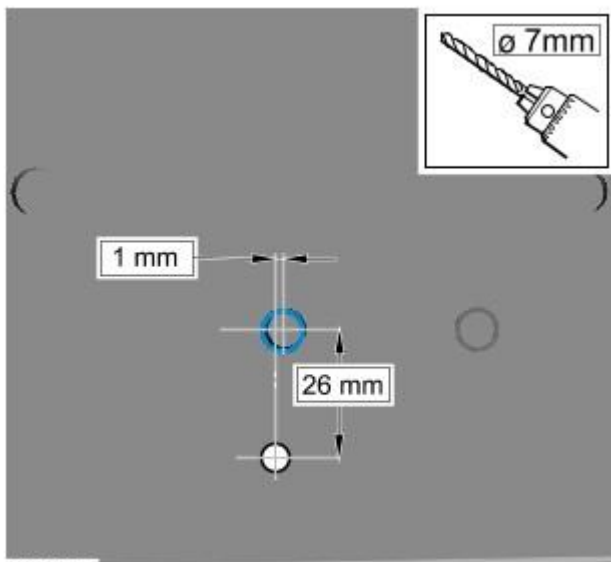
E137908

4. Using a 7mm drill bit, drill a hole in the position shown.

1. Mark a position that is 1 mm to the left (plus or minus 1mm) and 26mm (plus or minus 1mm) below the original left hand threaded hole.

2. Drill the hole.

3. Apply a suitable corrosion protection to the exposed metal.

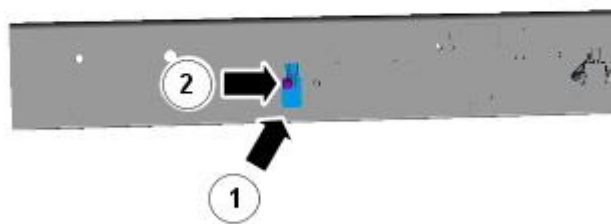
E137907

**CAUTION: Make sure that the sensor dowel is correctly located in the hole.**

Install the new sensor.

1. Install the dowel on the new sensor to the new hole.

2. Install the bolt and tighten to 10 Nm.
